**PILOT PROJECT FOR FARMER-MANAGED IRRIGATED AGRICULTURE UNDER  
THE LEFT BANK OUT FALL DRAIN STAGE I PROJECT, PAKISTAN**

**MAINTENANCE PLANS FOR IRRIGATION FACILITIES  
OF PILOT DISTRIBUTARIES IN SINDH PROVINCE, PAKISTAN**

*Volume Three*

*Bareji Distributary, Mirpurkhas District*

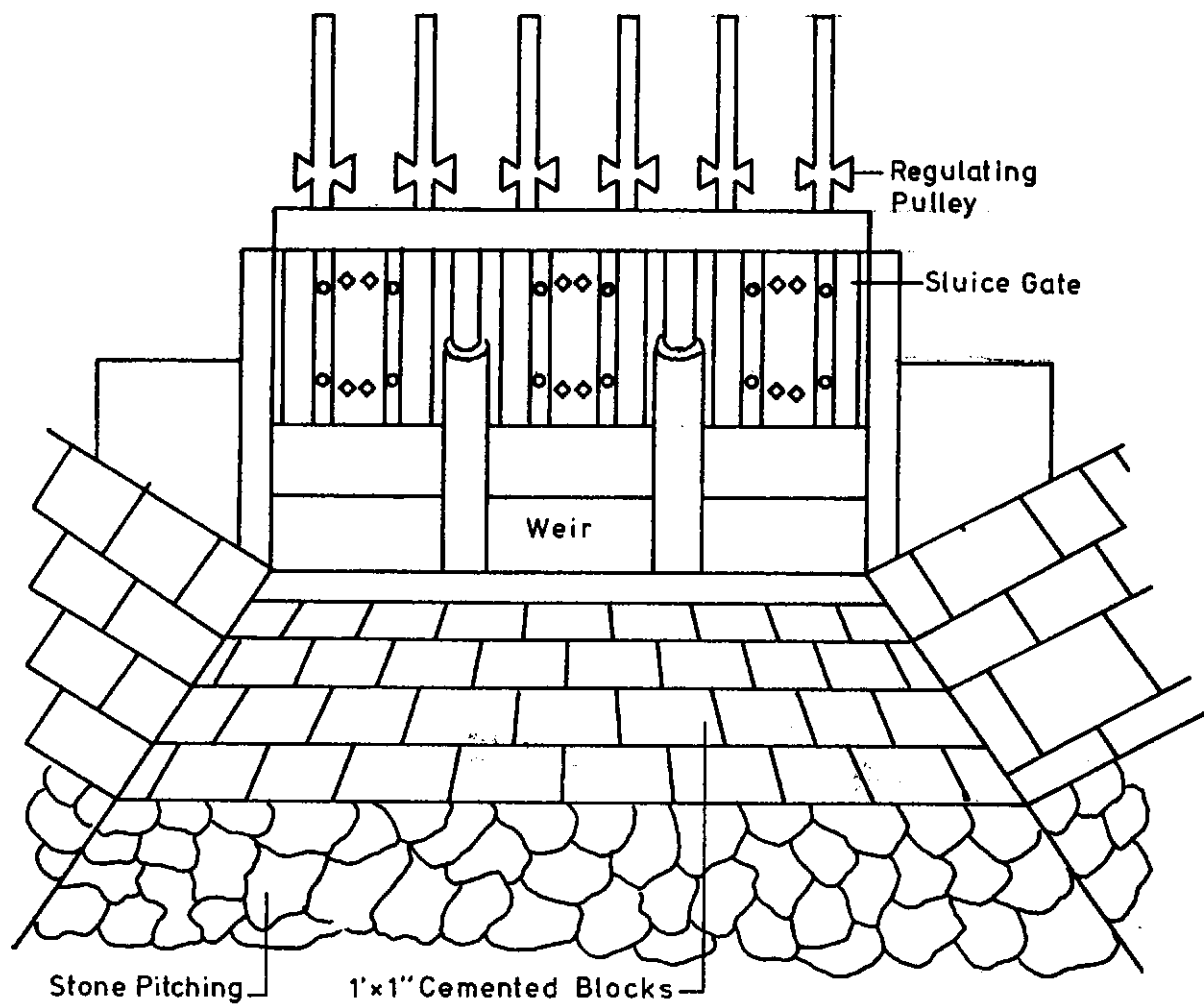
Figure A1. Head Regulator of Bareji Distributary.

downstream of the head regulator mainly because of free flow conditions at the head regulator. The width of the weir is 3.5 feet and it is in good condition. Stone pitching on the upstream side is also in good condition. Downstream of the weir an apron of friction blocks 10 feet in length is provided. Stone pitching follows the friction blocks and is 19.5 feet in length. About 50 feet downstream of the stone pitching, there is erosion which has resulted in increased flow depth of the distributary channel at that place.

**Causes** Heavy silt accumulation on the left gate of the Head Regulator is due to partial opening of the left gate. Because of partial opening, the velocity of water is reduced at the left gate and consequently silt is deposited.

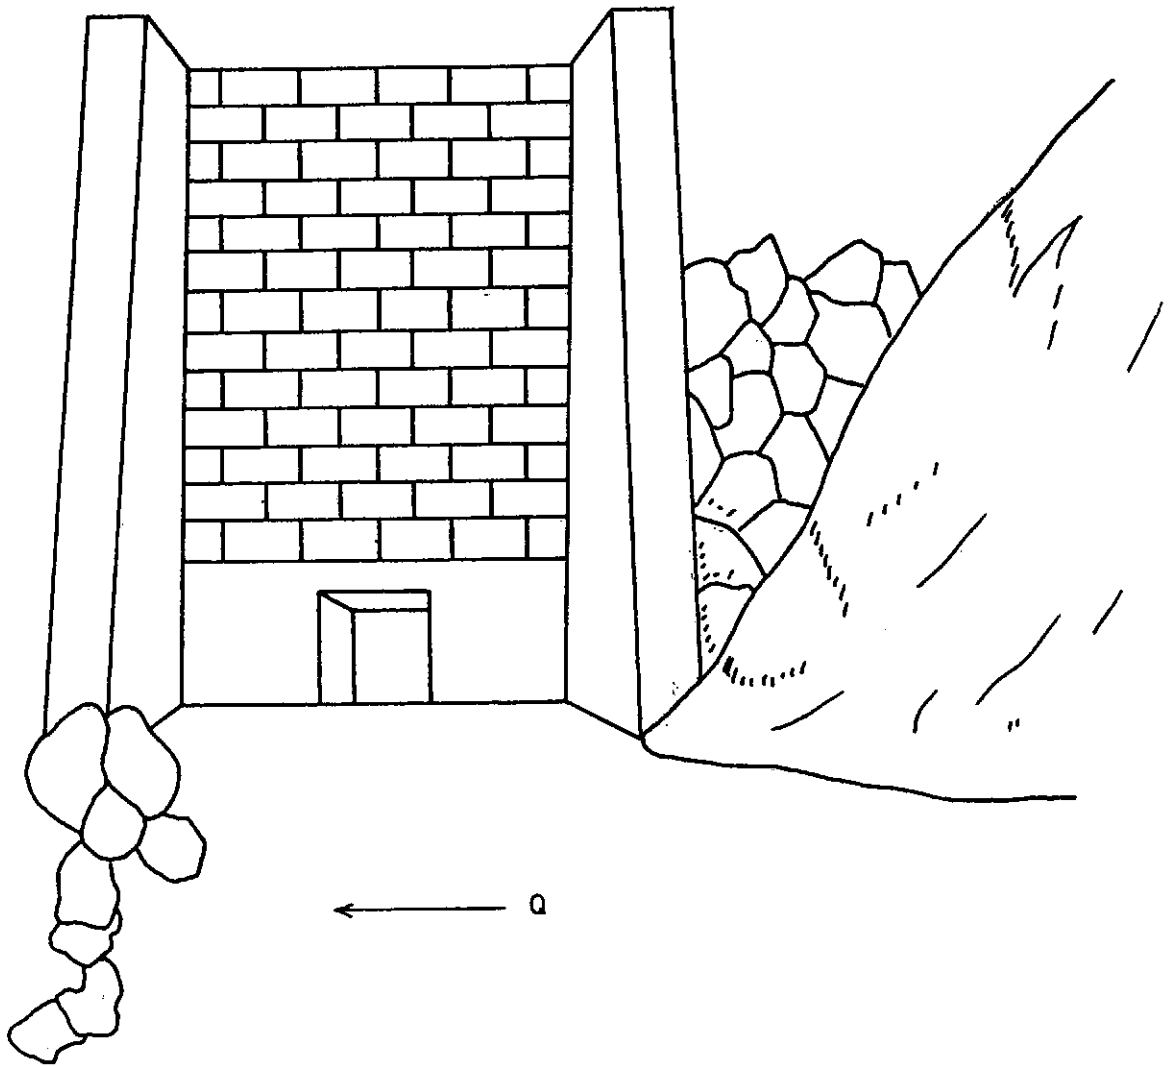
Figure A2. Single orifice structure Outlet No. 240/1R (1R).

**Causes** The accumulation of rocks has been done deliberately to head up the water for drawing more water and cultivating additional areas.

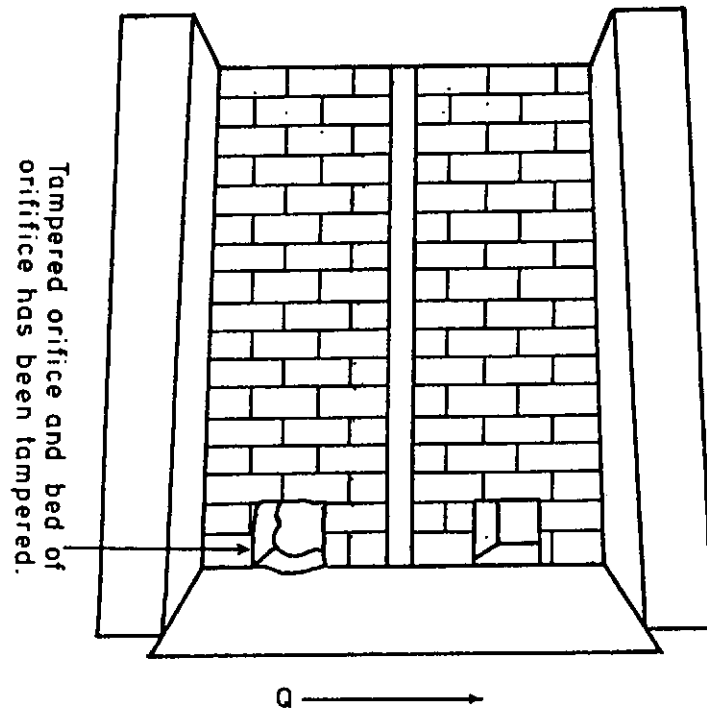
Figure A3. Double orifice newly constructed Module 239/1L (1L).

**Situation** This module is a newly constructed double orifice. The orifice on the left is tampered. The area of the right orifice is 0.231 square feet. There is some stone deposition at the face of the outlet to divert more water into the outlet. The tampering has not significantly affected the discharge rate as it was hammered with an iron instrument. The right orifice is in good condition (see Figure A3).

Causes	The practice of tampering and rock accumulation in front of the outlets is done to get extra water for cultivating more land or to get enough water during the days of shortage.
Remedy	The tampering of the orifice can be repaired using cement and fine aggregates. Rocks can be removed in consultation with the WUA.

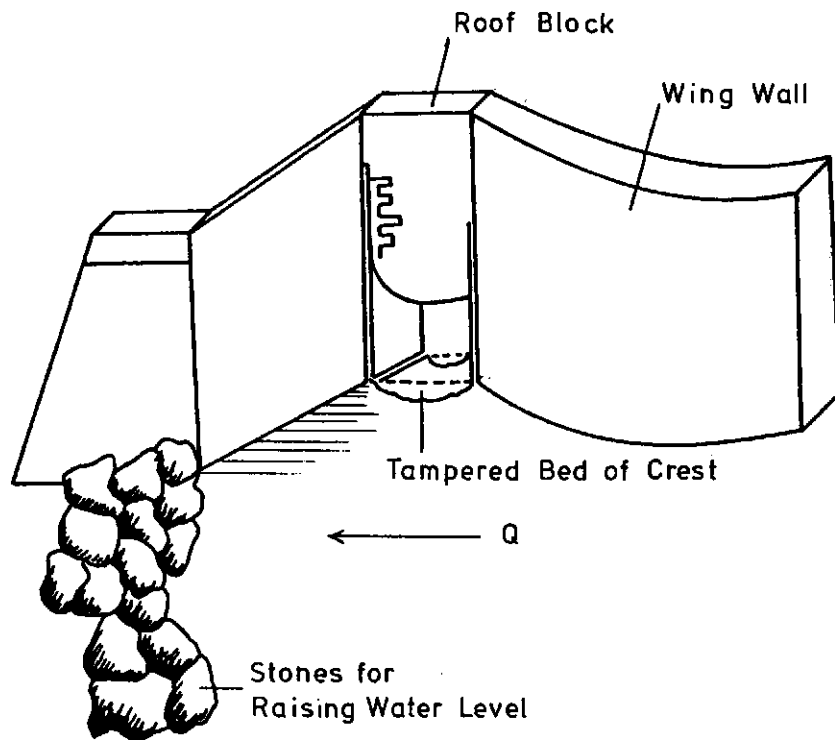
Figure A4. Outlet 240/1AR.

Situation	The module is an old single orifice structure. The orifice is made up of a cast iron frame with graduations. The orifice is tampered in the bottom and rocks have been accumulated in front of the outlet (see Figure A4). The area of the orifice is 0.313 square feet.
Causes	Rocks have been accumulated and the orifice bed is tampered to draw more water.
Remedy	Rock accumulation may be removed by the cooperation of the WUA. Tampered outlet can be repaired by ordinary masonry work.

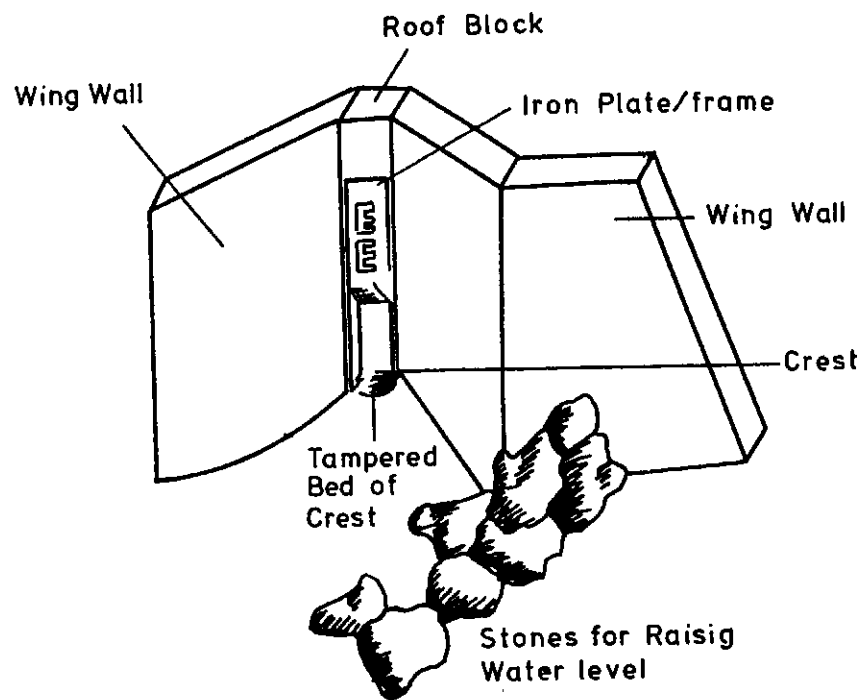
**Condition** The module is an old single orifice structure. The orifice is made of a graduated cast iron frame. The module draws water with more pressure as the bed of the orifice is tampered and bulky stones have been placed in front of the outlet. There is heavy silt deposited at the outlet (see Figure A6). The watercourse is lined. The area of the orifice is 0.70 square feet.

**Causes** Tampering and placing of bulky stones in front of the outlet is done to get more water for cultivation. The design of the module is such that it faces directly the stream flow. Silt deposition takes place mainly due to the lack of excavation.

Figure: A6. Typical view of tampered crest of the outlet numbers 3L, 4L, 5L, 6L and 8L.

**Remedy** Excavation of the channel must be done regularly. Tampering may be repaired by ordinary masonry work. Bulky stones may be removed by the cooperation of the concerned WUA.

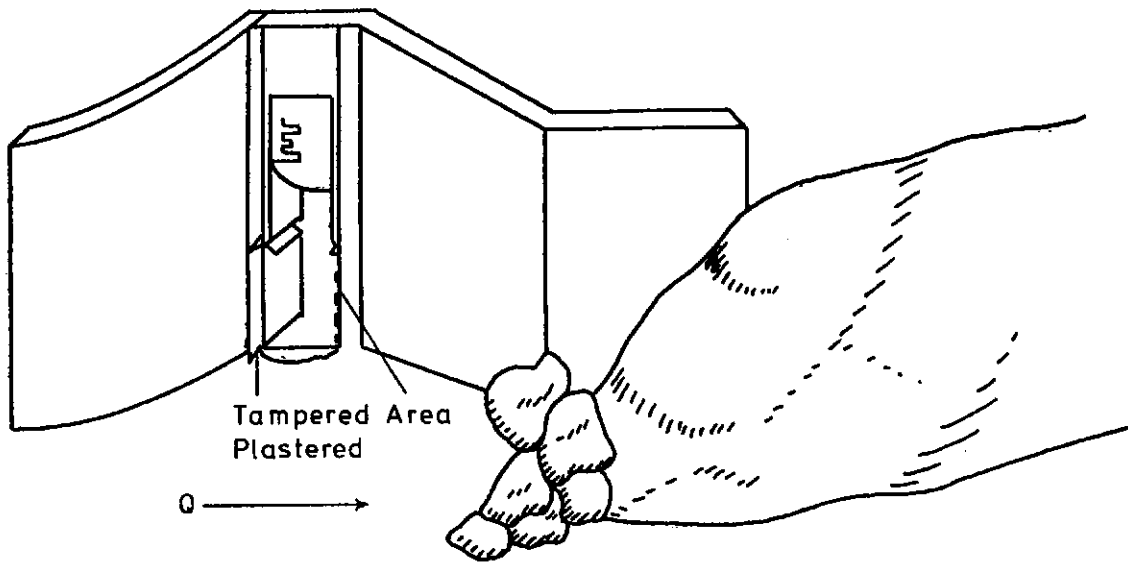
- Situation** The module is an old single orifice structure made of a cast iron frame which is graduated on both sides. The outlet is tampered in the bottom. There is heavy silt deposition and rock accumulation in front of the outlet (see Figure A6). The area of orifice is 0.31 square feet.
- Causes** Tampering and the accumulation of rocks are done in order to get more water during the periods of water shortage. The silt deposition is mainly due to the accumulation of rocks in front of the outlet.
- Remedy** Tampering may be repaired by normal masonry work.  
Rocks may be removed and stopped in the future through the cooperation of the WUA.

Figure A8. Outlet 7L tampered deeply and from sides.

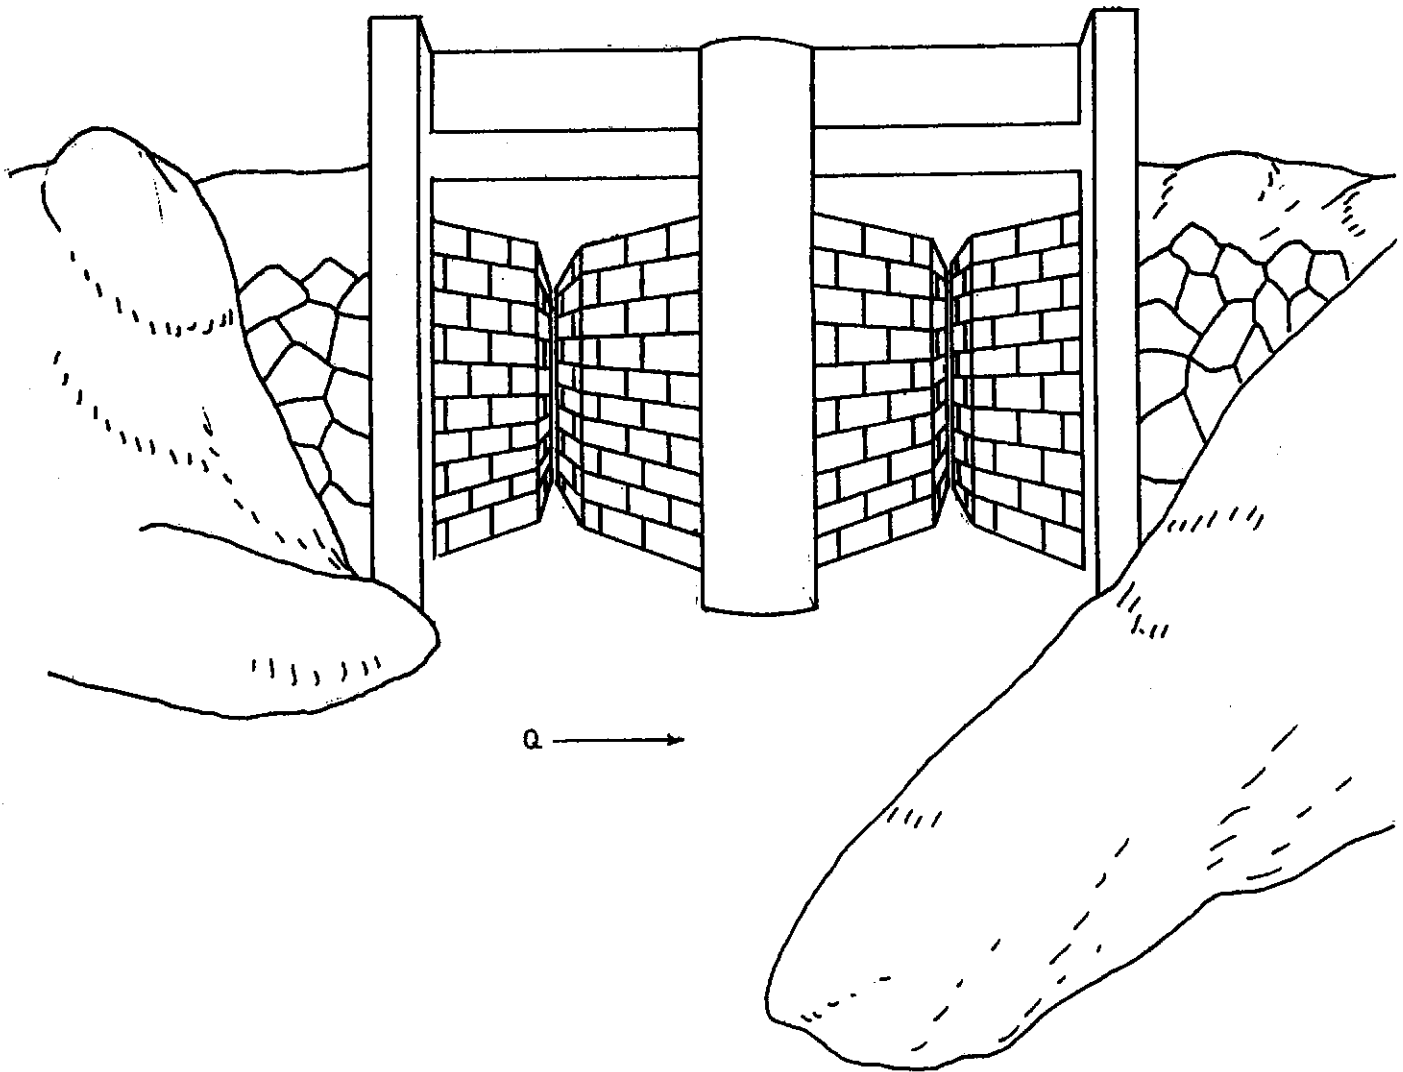
- Condition** The module is a double inlet open flume constructed recently. A great amount of silt is deposited in front of the outlet, which affects the flow of water. Stones are also placed in front of the outlet (see Figure A9). The measured throat width of each outlet is 0.307 feet.

<b>Causes</b>	Silt deposition takes place due to the low velocity of water at this section of the distributary. Stones are placed to divert more water into the outlet.
<b>Remedy</b>	Silt may be removed. Stones may be removed through the cooperation of the WUA.

Figure A9. Two venturi flume china-made structures as  
Outlet numbers 9L.

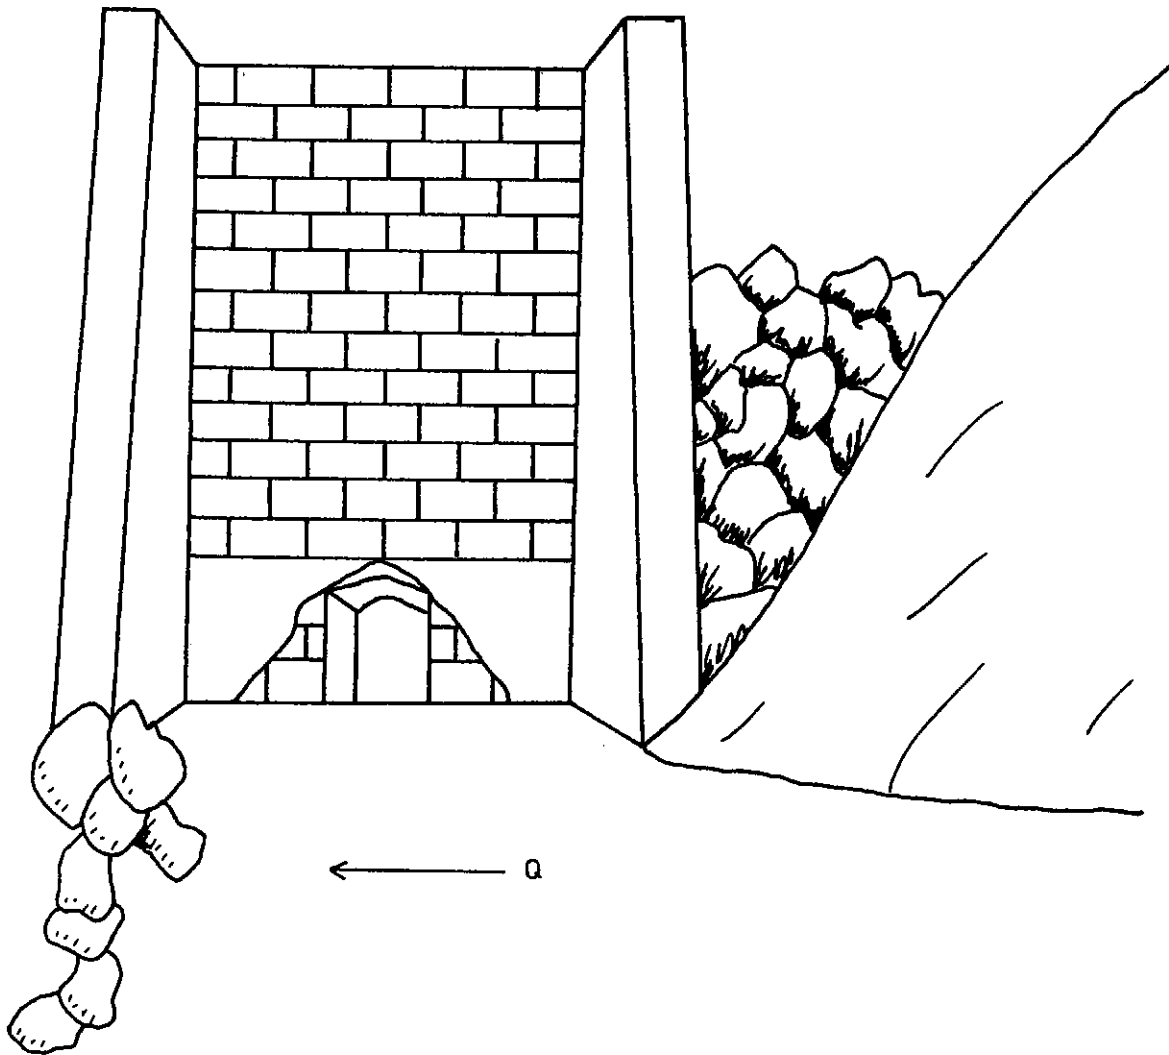
<b>Condition</b>	The module is a single orifice constructed recently. The outlet is tampered. Heavy silt deposition at the outlet face affects the flow of water into the outlet (see Figure A10).
<b>Causes</b>	Tampering is done in order to get more water for cultivation. Heavy silt deposition at the face of the outlet is due to the lack of excavation and also because of the low water velocity.
<b>Remedy</b>	Desilt the outlet in a proper manner. Tampering may be repaired by masonry work.

Figure A10. Single orifice structure Outlet 7R.

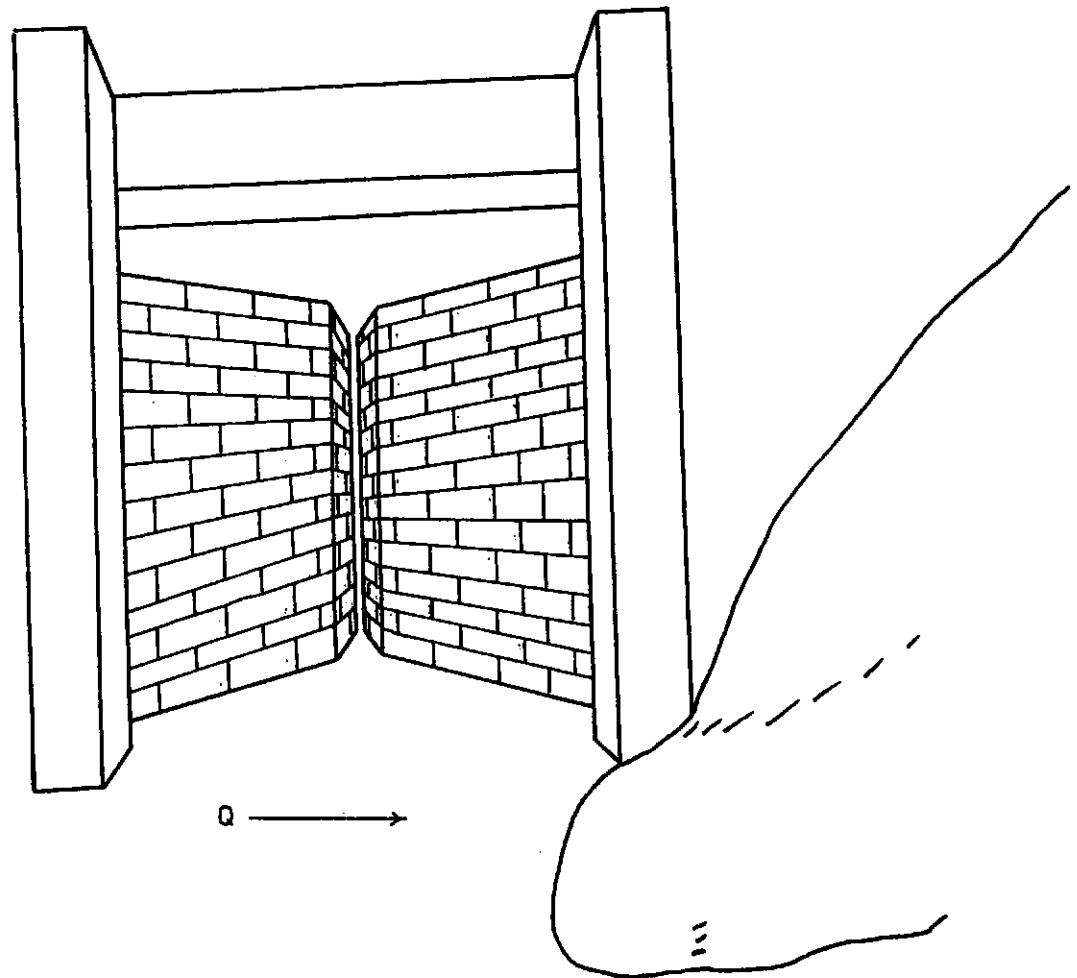
<b>Condition</b>	Both modules are single inlet open flumes constructed recently. There are heavy silt deposits in front of both outlets. Stones are also placed in front of the outlets to divert more water into them (see Figure A11). The throat widths are 0.936 and 0.502 square feet, respectively.
<b>Causes</b>	Silt deposition is due to improper maintenance of the watercourse. Stones are placed in order to divert more water for cultivation.
<b>Remedy</b>	Desilt the watercourse in a proper way. Remove the stones by the cooperation of the WUA.

Condition	The module is a single open flume outlet constructed recently. There is heavy silt and bushes in front of the outlet (see Figure A11). The throat width is 1.074 feet.
Causes	Heavy silt and bushes due to a lack of maintenance.
Remedy	Proper maintenance is required.

Condition	The module is a single inlet open flume newly constructed. There is little silt in the front of the outlet (see Figure A11). There is not any significant problem and the outlet is functioning properly. The throat width is 0.47 foot.
-----------	--

Figure A11. Single venturi flume structures as  
Outlet numbers 8R, 9R, 10R, 11L, 12L and 11 R.

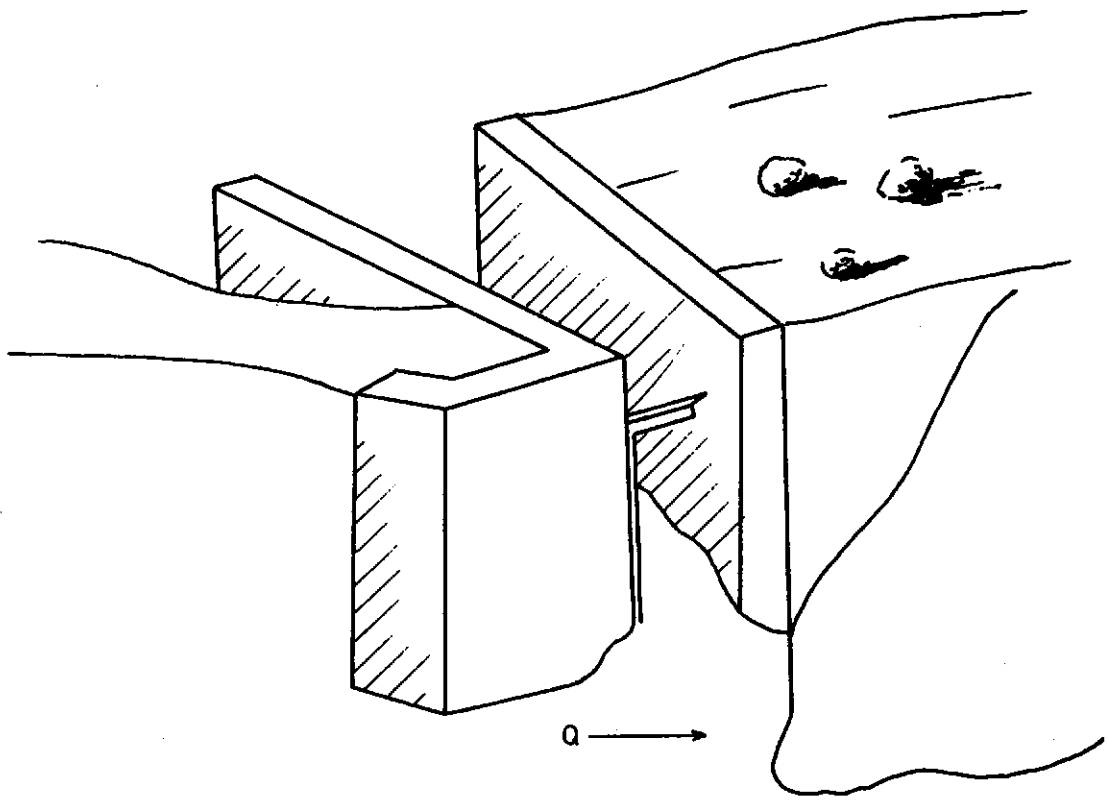
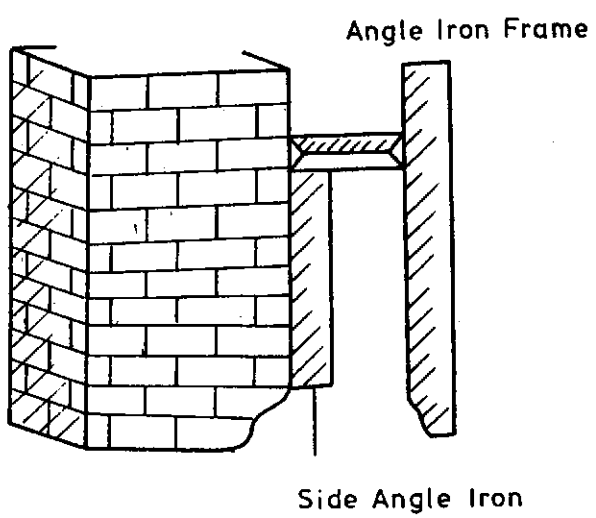
Figure A12. Outlet - 225/1AL.

<b>Condition</b>	The module is an old single orifice structure with a cast iron frame without graduations on any side. The outlet is tampered (see Figure A12). The area of the orifice is 2.364 square feet. With full supply in the distributary, the structure becomes submerged in the water.
------------------	--

Causes	The water overtops due to the physical situation of the outlet. The top edge of the structure is below the full supply level in the distributary. Tampering is done in order to get more water, especially during the periods of water shortage.
Remedy	The outlet may be reconstructed. Tampering may be corrected by masonry work.

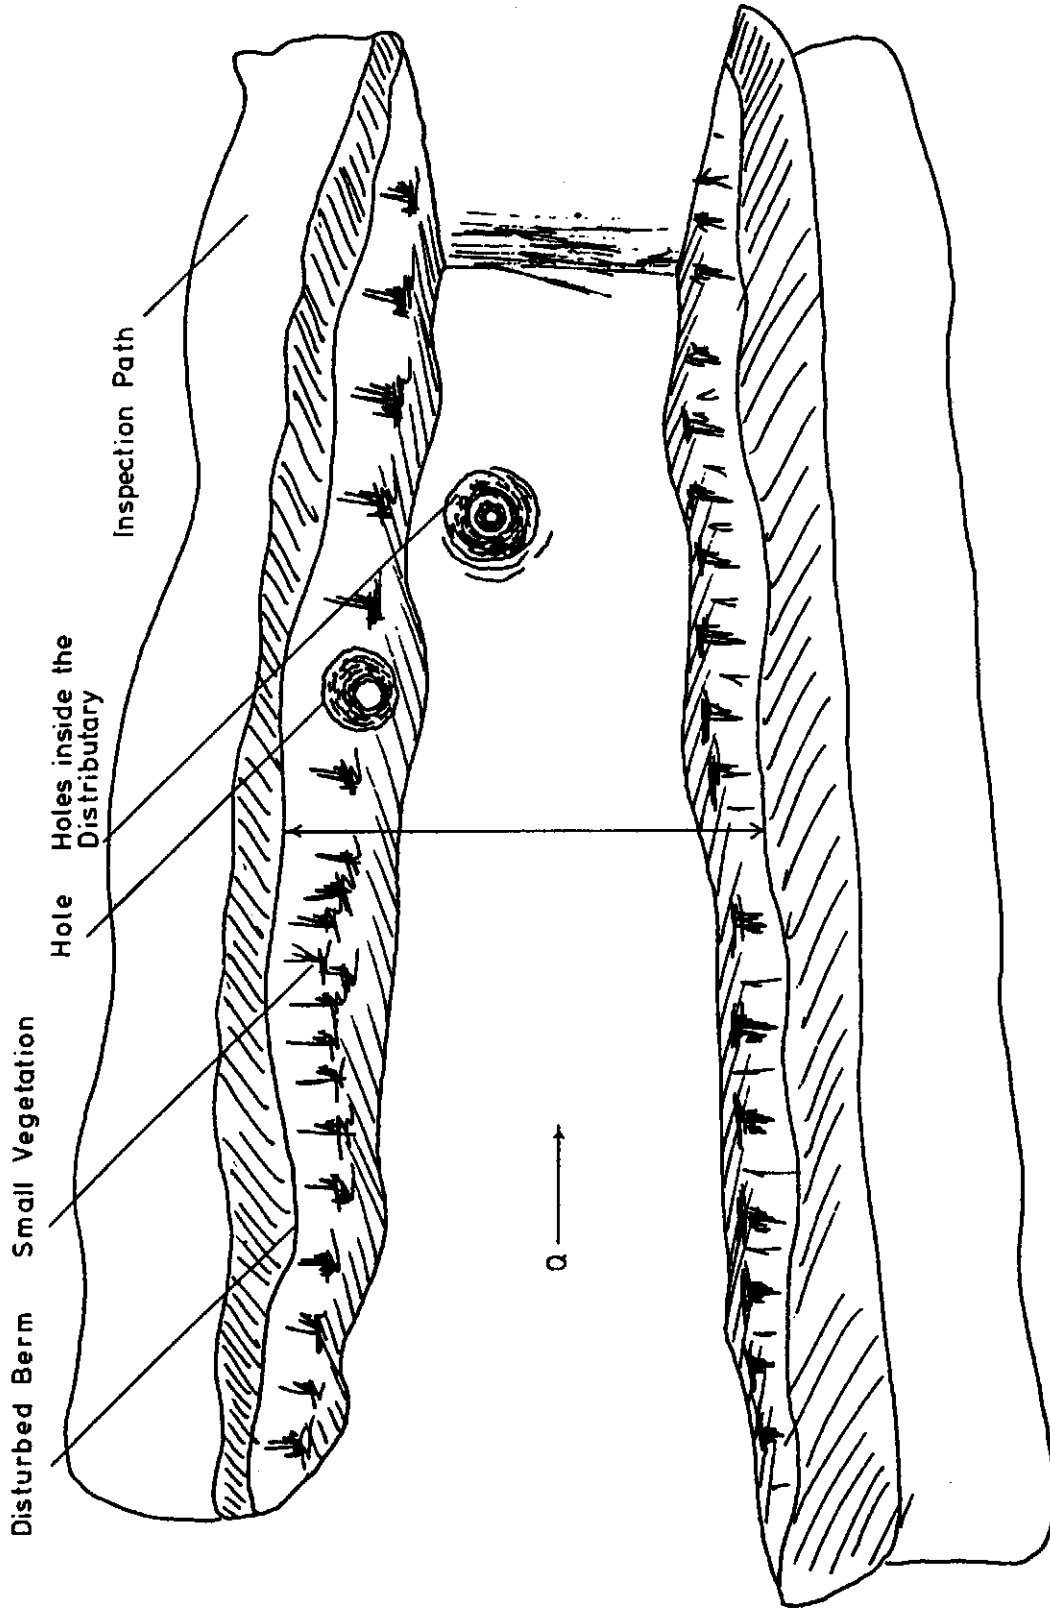
The width has decreased while the depth has increased. This has resulted in increased flow depth. The banks are stable. The berms are not well maintained. Six watercourses offtake from this reach of the distributary. Besides these six legal outlets, one illegal watercourse is being fed from the distributary without an outlet structure. There are two overhead bridges for crossing the channel in this section (see Figure B5).

- Causes** The main reason for deep desilting of the distributary was to get more water at the tail portion because they use lift machines at some watercourses. The tail of the distributary has no outlet structure. The lack of the berm width and adequate freeboard is due to improper maintenance. The banks and the berms are disturbed due to the crossing of animals and the washing of clothes.
- Remedy** Appropriate maintenance practices may be followed in the future to overcome many of the problems being faced presently.

Figure B 5. Sketch of Bareji Distributary from RDs 12.1 to 39.31.
