Water Shortage in the Lower Deduru Oya Basin

K. N. J. Katupotha

*Department of Geography, University of Sri Jayewardenepura, Gangodawila, Nugegoda,
Sri Lanka*

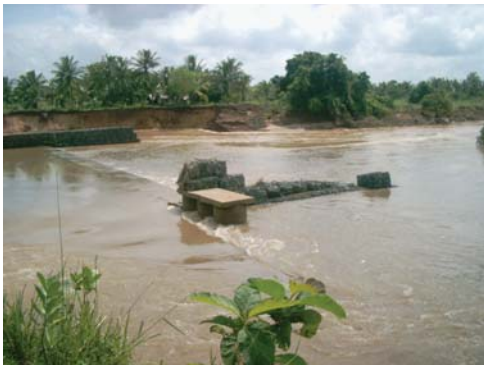
Damages caused by flood water at the Deduru Oya dam close to Puliyankulama.

Silt and muddy water create water pollution by flash floods, bank erosion and sand transportation routes at the river (Photos A, B, and C). Photo [D] shows the lateral seep of water from the ground into the river due to deepening the river bed. Likewise, unavailability of water, farmers gradually shifted to cultivate leafy and other vegetables in paddy fields in the LDOB.

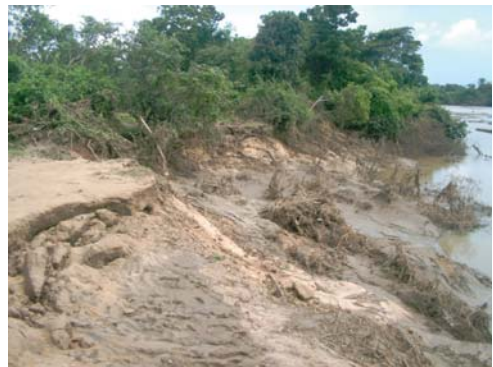
Example of a damaged river bank.

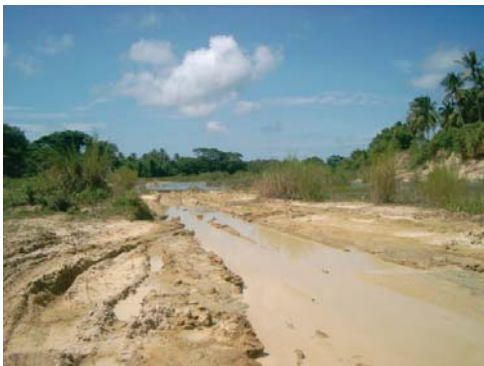
Sand transportation routes at the river.

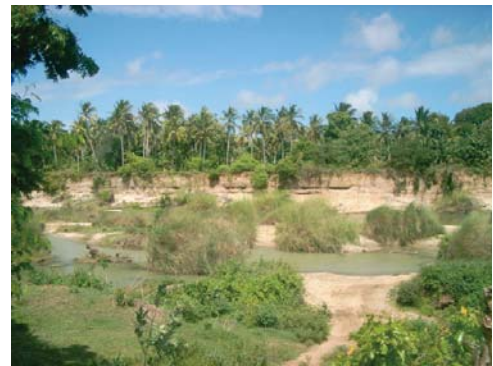
The groundwater level in the area was around 8–12m historically. This was increased up to 30 m. The amount of water flow in the Deduru Oya also has reduced. Moreover, in some places, water is not flowing due to a lesser amount of water and due to the deepening of the river. About 20 years ago, the river bed was about 6–8 m from the surface level and today the depth of the river bed is 12–15 m below the river bank. This has resulted in groundwater flowing into Deduru Oya through lateral seepage (Annex 1, D).

Bank erosion threatening coconut trees and surface water flow towards the river bed.

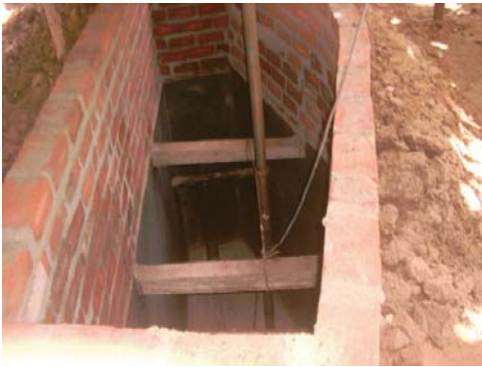
The farmers drop the instruments to the bottom of a former used well to obtain deep water.

Farmers put tubewell instrument at the bottom of wells to obtain deep water for cultivation and other purposes [Photos: G, H, I and J]. The tubewells and normal wells [Photo L] waters with suspended and dissolved impurities in are not suitable for irrigating crops and using for domestic purposes.

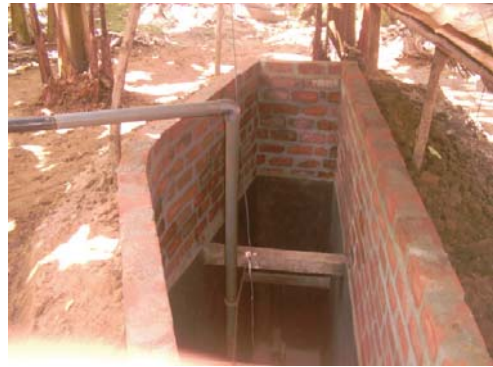
Aspect of the dropped tubewell instruments (same well).

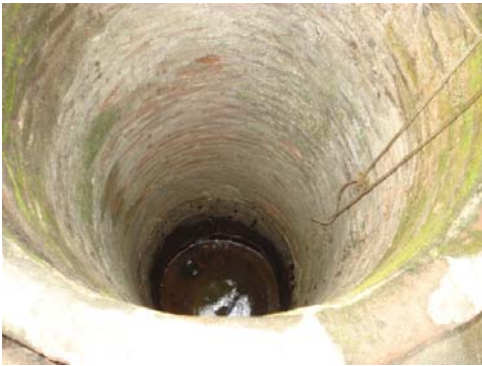
Lowering of water level of surface wells due to excessive sand mining in the area.

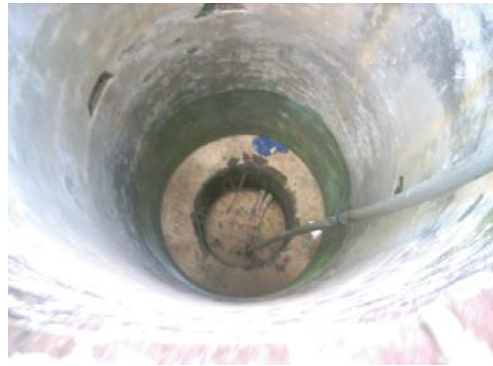
Aspect of the dried well and dropped tubewell instrument to the bottom.

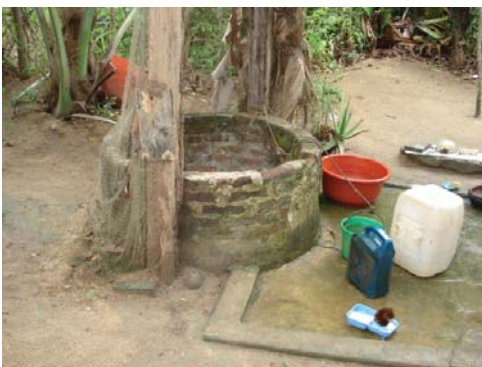
Water of this well cannot be used due to the low salinity and other impurities.

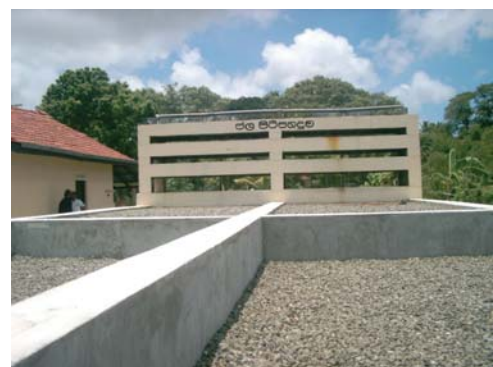
Community water supply scheme at Ariyagama, The tubewell at this place is 30 m deep from the surface level.
