CHAPTER 6

Conveyance Structures

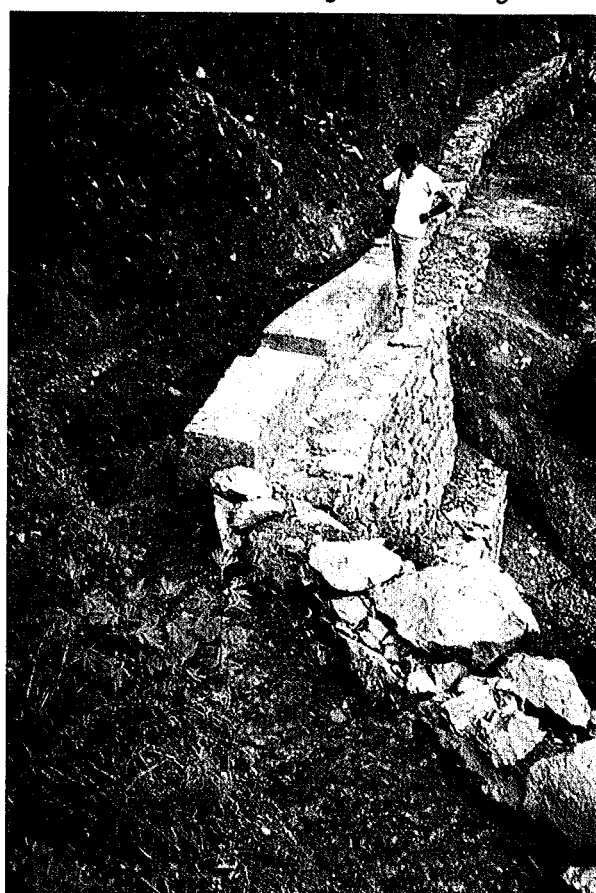
Figure 6.0.1. A level crossing in Nepal where the spillway crest is too high above the canal bed. The spillway should be wider and an orifice should be constructed to control drainage water entering the canal.

The level crossing discussed in Example 6.3 is a simple but effective structure in many situations when constructed properly. Figure 6.0.1 shows a level crossing with several defects. The sill level of the overflow is nearly at the same elevation as the downstream sidewalls. It should be lower and extend the entire length of the structure instead of being a small opening. In addition to improving the sill, discharge that enters the canal from the outlet end of the structure should be controlled. By adding a block in the canal at the downstream end of the structure with an orifice designed to limit the flow to no more than the canal design capacity, excess water will spill harmlessly over the overflow sill. Since cross drains are natural drainage ways, they should be utilized to dispose of all excess water in the canal.

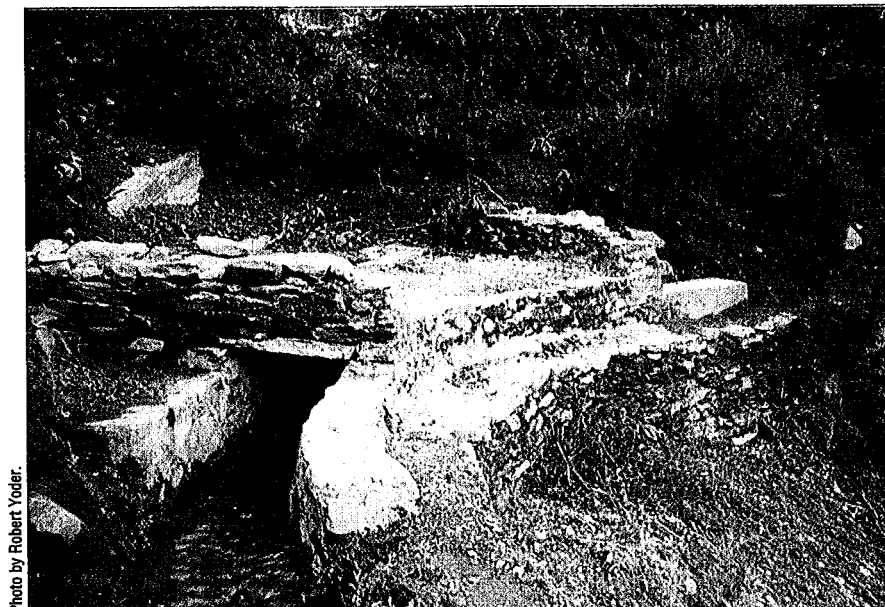
Figure 6.0.2. Superpassage in Nepal that should have been shifted several meters toward the hillside.

A superpassage is a common and effective method for crossing drains with heavy bed loads. Example 6.4 illustrates several important points. The downslope side of the structure must be adequately protected or the structure will be undermined and will fail. A frequent mistake is made in the placement of superpassage structures. Figure 6.0.2 shows a superpassage built in Nepal

that is set too far away from the hillside. The high velocity stream of water will excavate and eventually damage the upslope side of the structure. This also increases the drop on the downstream side making protection more difficult. The entire structure should have been shifted several meters toward the hillside. This would have required additional excavation of the canal and structure but would have given better protection. Figure 6.0.3 shows a more satisfactory superpassage in Nepal where the structure is nestled against the rock. A trickle of water from the cross stream can be seen entering the canal through a small opening in the top of the masonry protection. During periods of high discharge the entire stream passes over the structure.

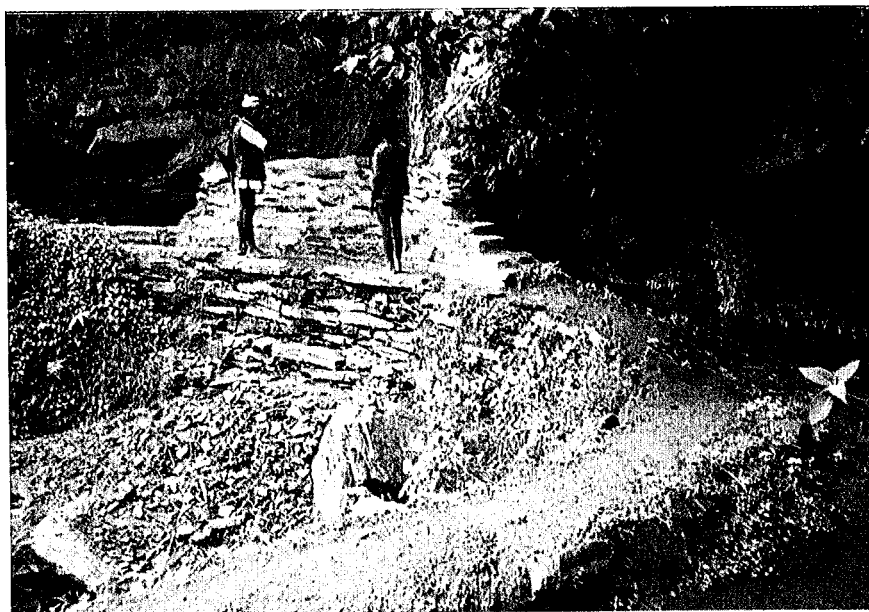
Figure 6.0.3. Superpassage in Nepal built against the hillslope.

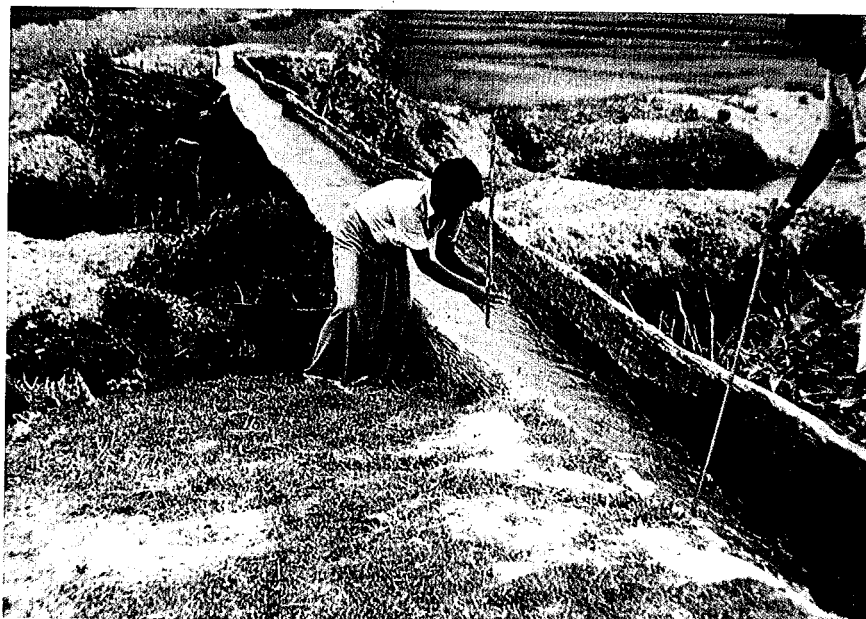
Figure 6.0.4. Hollow log used as an aqueduct in Nepal.

Hollow logs have been used by farmers as aqueducts for centuries. Figure 6.0.4 shows a large log aqueduct being used in Nepal. This indigenous solution to crossing drains has been successful. Such log aqueducts are also frequently used as flow-limiting structures. All excess flow in the canal overtops the aqueduct and spills into the stream; a safe location for disposal of excess canal water. This factor must be remembered when new structures are built to replace traditional structures. However, deforestation is making it necessary to replace forest products with a viable alternative. Example 6.5 suggests a ferrocement option that needs to be explored further.

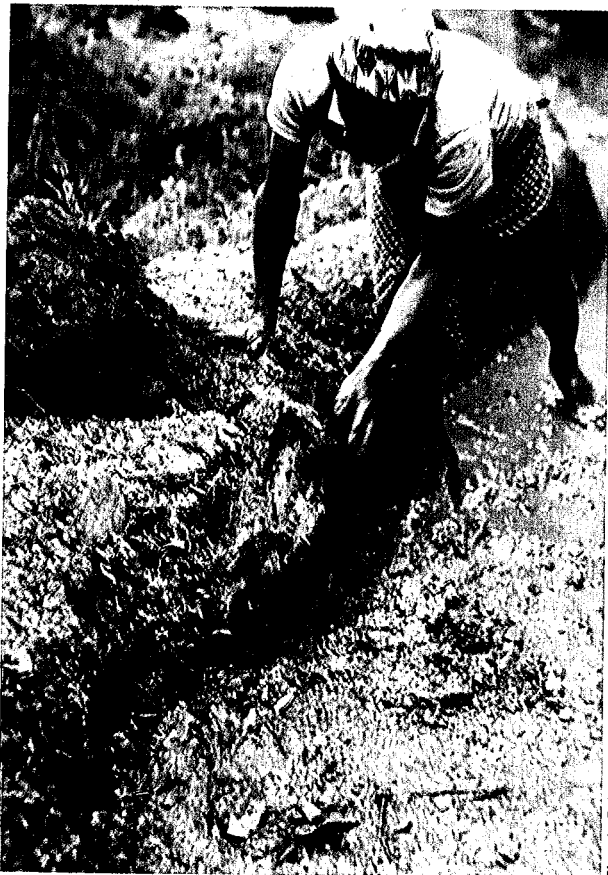
Figure 6.0.6. Red-clay lining applied by farmers as a temporary measure to reduce water losses from the canal during a critical water-shortage period.

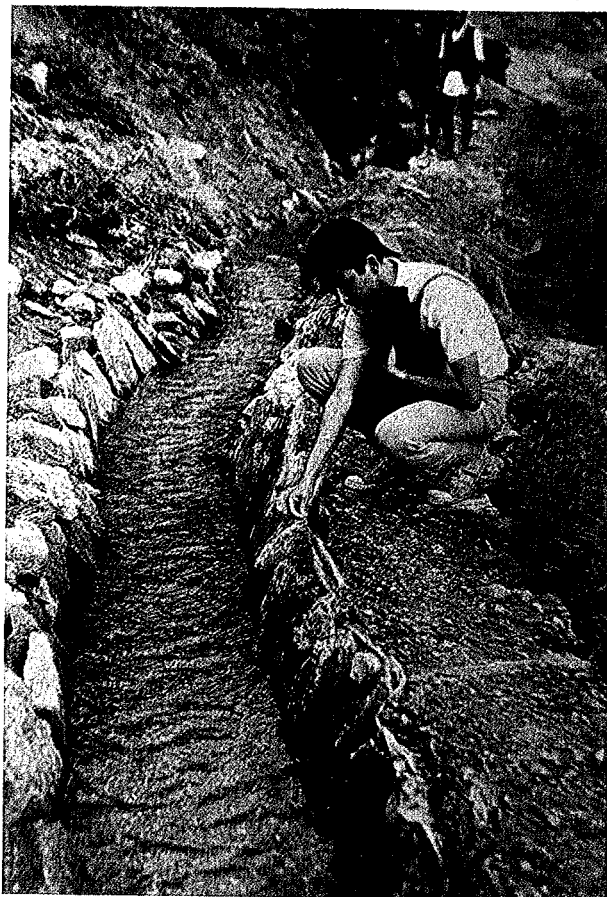
Figure 6.0.7. Plastic sheet used to reduce seepage from a canal in a landslide zone in Sindhupalchok, Nepal.

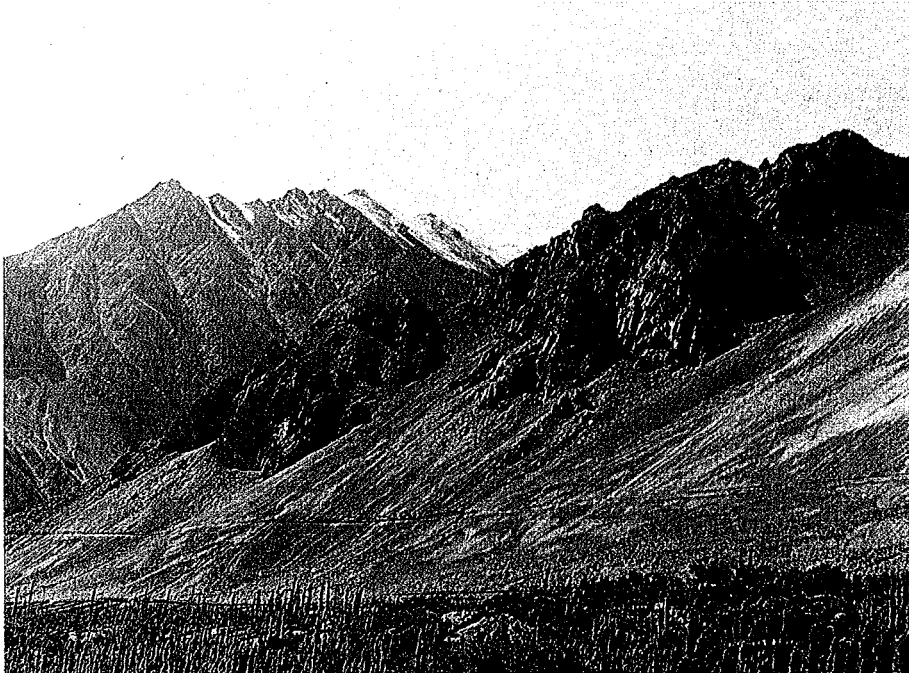
Figure 6.2.6. View of part of the previously developed command area with the channel visible as a line on the scree.

slopes are acceptable under certain conditions, they lead to rapid erosion in the scree area and destroy the channel. The traditional slope has a very low velocity. AKRSP engineers selected a slope of 1/600 as a middle option for the Aliabad channel. Figure 6.2.6 shows the channel crossing the scree.

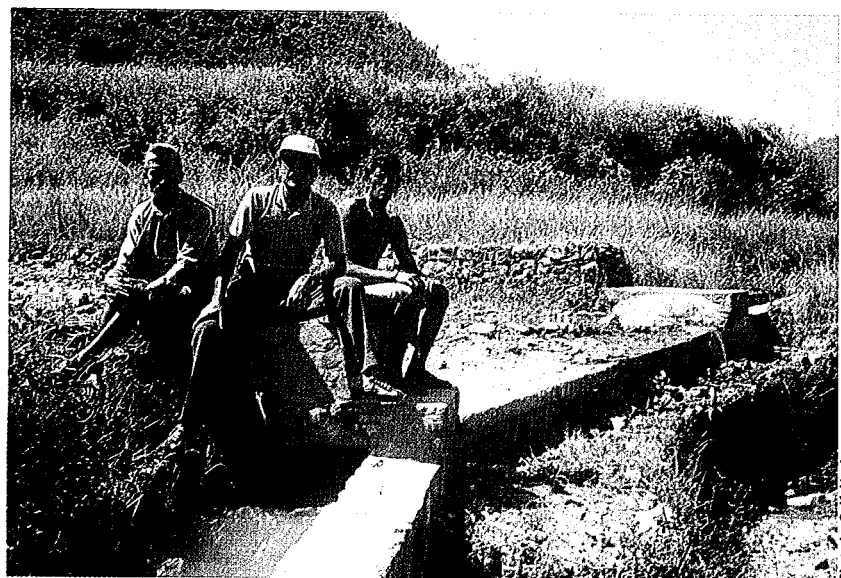
Figure 6.4.2. Completed superpassage in the Dhand Khola Irrigation System, Kabhrepalanchok District, Nepal.

masonry guide walls were built to channel the water through the superpassage. Gabions were used to extend the sidewalls upstream (Figure 6.4.2).

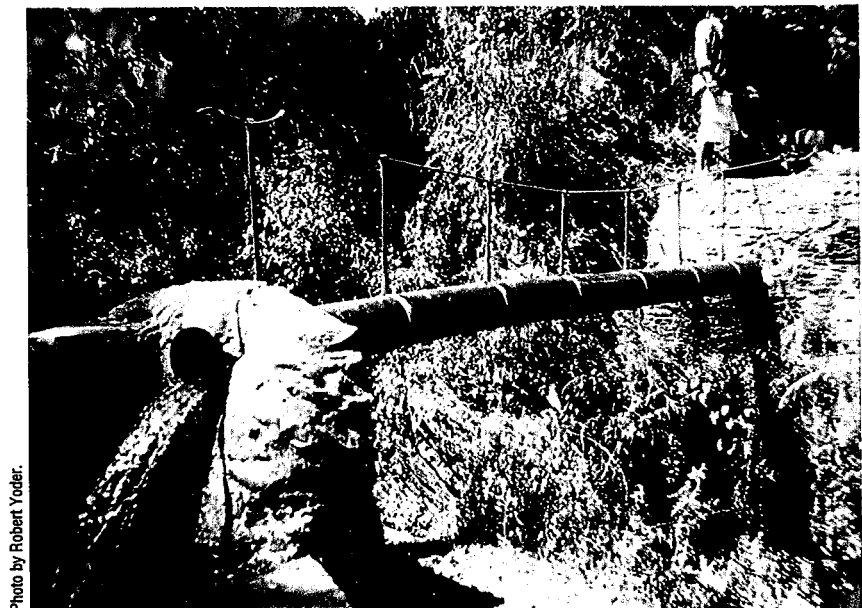
Figure 6.6.1. Suspended pipe aqueduct in Sindhupalchok, Nepal.

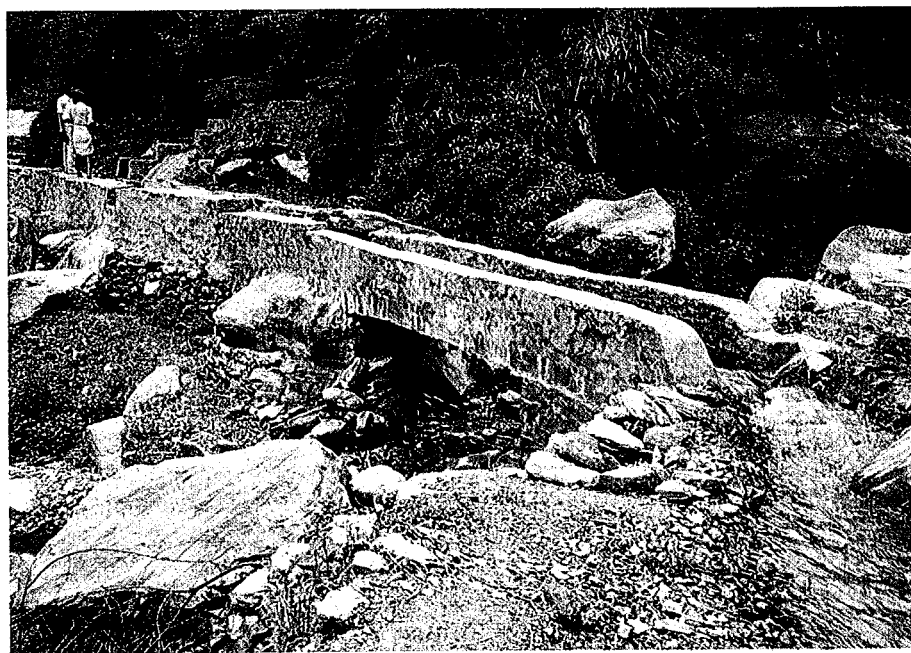
Figure 6.7.3. Reinforced concrete aqueduct with collapsible side walls, Sindhupalchok, Nepal.

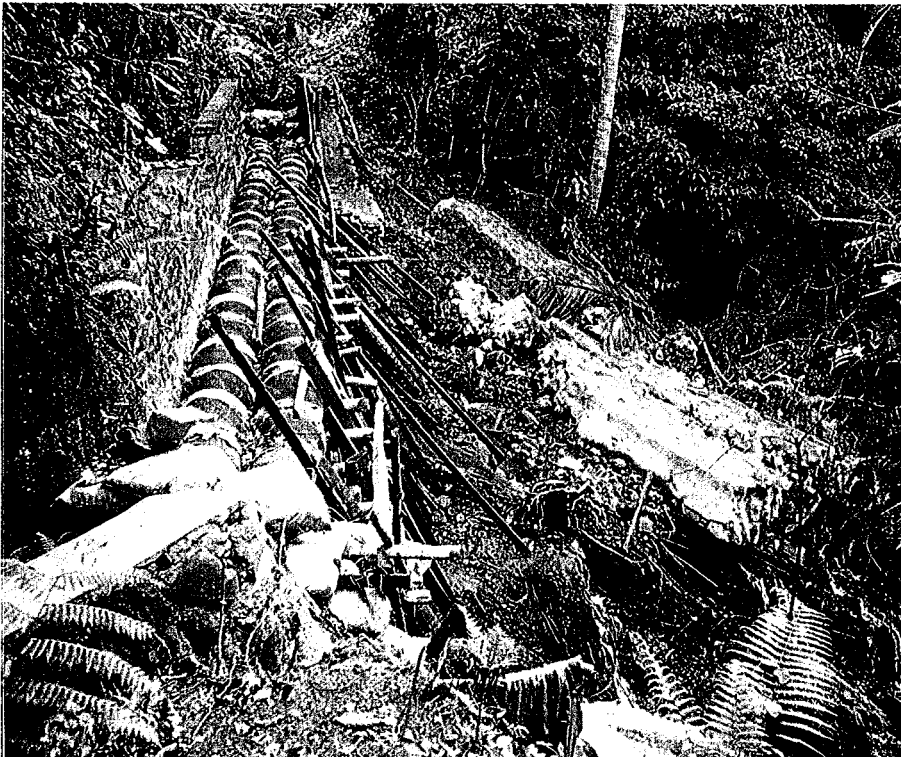
Figure 6.9.1. Pipes made from drums joined with bituminous-covered fabric which replaced a collapsed masonry wall, Bali, Indonesia.

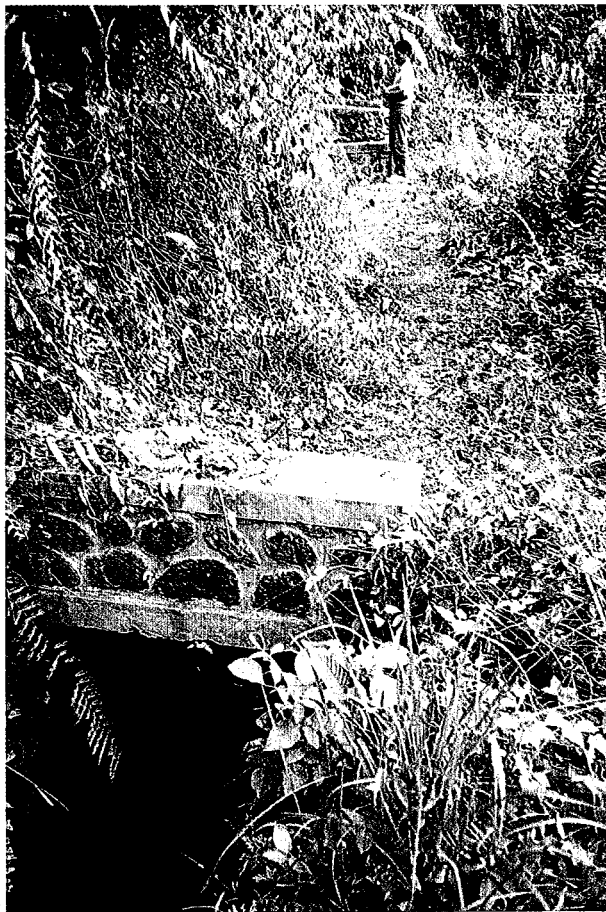
Figure 6.9.2. Concrete slabs used to cover masonry canal, Bali, Indonesia.

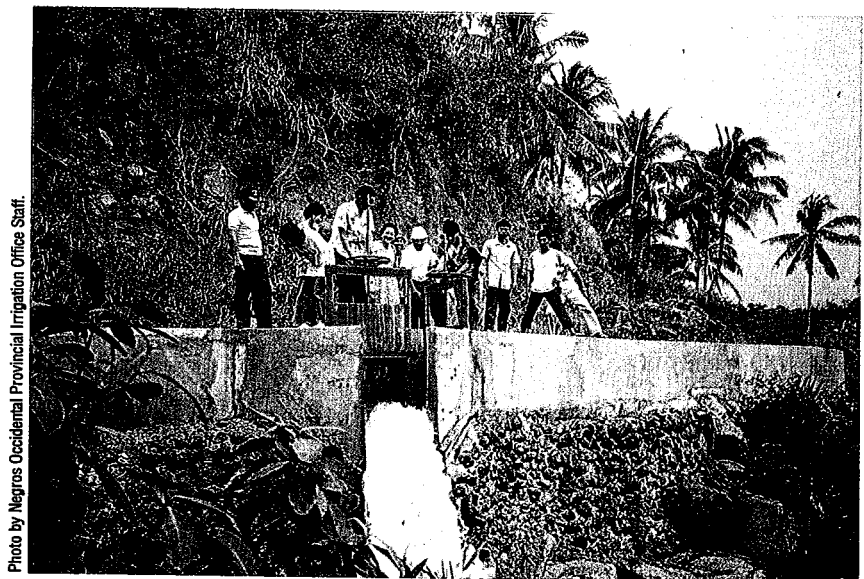
Figure 6.11.1. Sluice gate and inlet gate upstream of the bench flume in the Cabacungan Communal Irrigation System, the Philippines. The bench flume runs for 90 m to the right of the group of people.

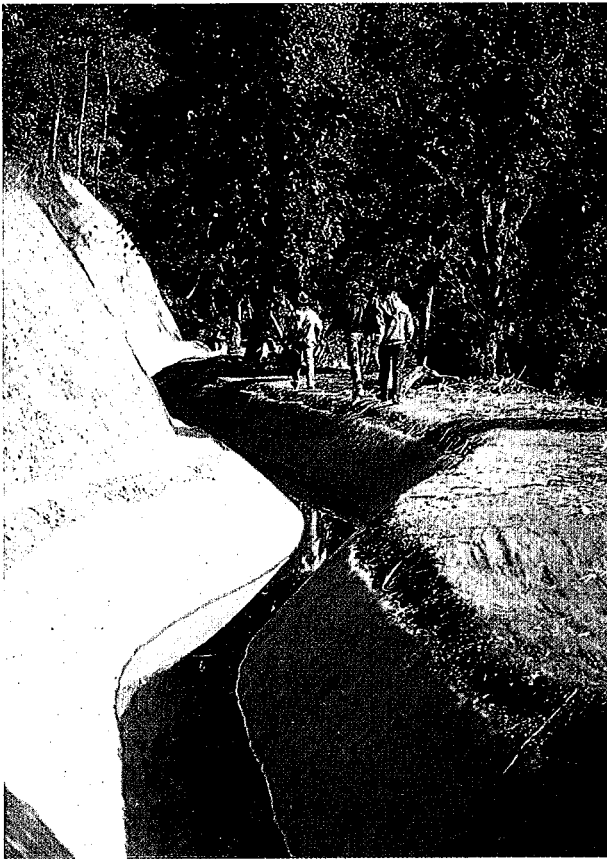
Figure 6.14.1 Soil-cement lined section of canal, Andhi Khola Project, Nepal.

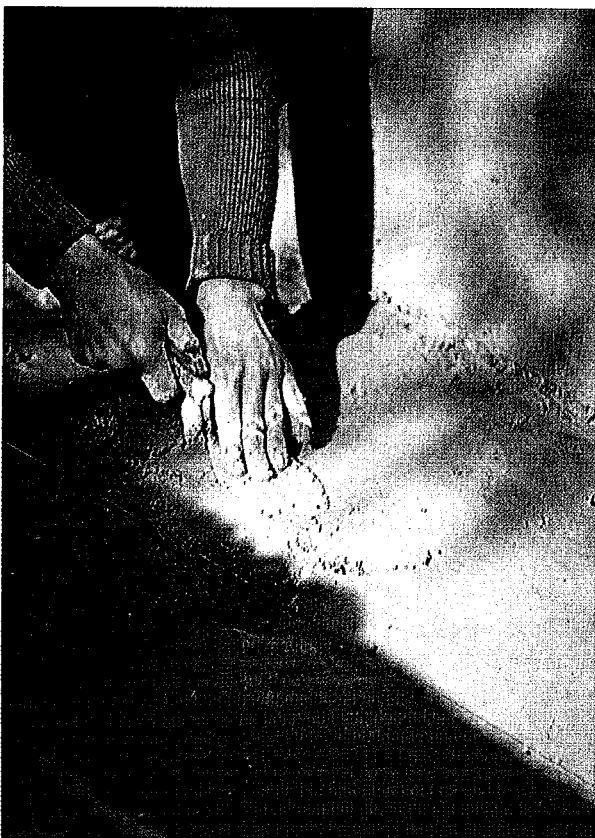
Figure 6.14.3. Soil-cement application for lining canal in Nepal.

Since the project has external funding, there have been some possibilities for experimentation and risk-taking. With this in mind, the project decided to try lining some trial sections with a 40 mm layer of soil cement. Sieved red soil (which is locally available), and sand and cement were mixed at the ratio of 10:1:1, respectively. After mixing the above dry ingredients with shovels, water was applied and mixed in thoroughly. The surface to receive the mortar was wetted, then the mixture applied firmly and packed tightly to eliminate air pockets. The surface was troweled shiny smooth and then kept humid for a minimum of one week (Figure 6.14.3).

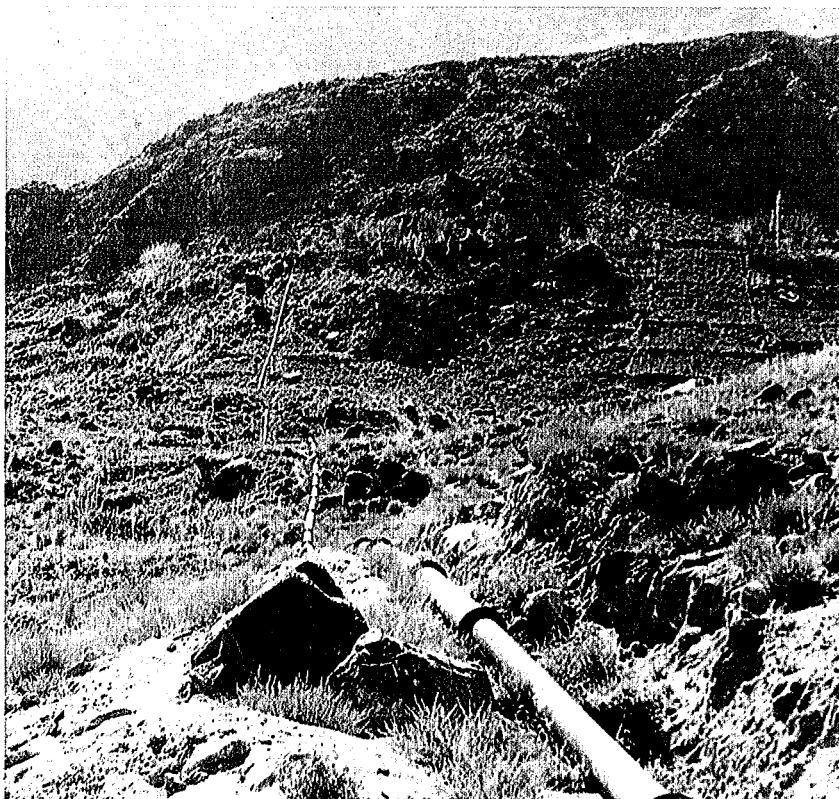
Figure 6.16.2. View, from near the inlet tank, of the siphon pipe crossing the valley, Chalt, northern Pakistan.

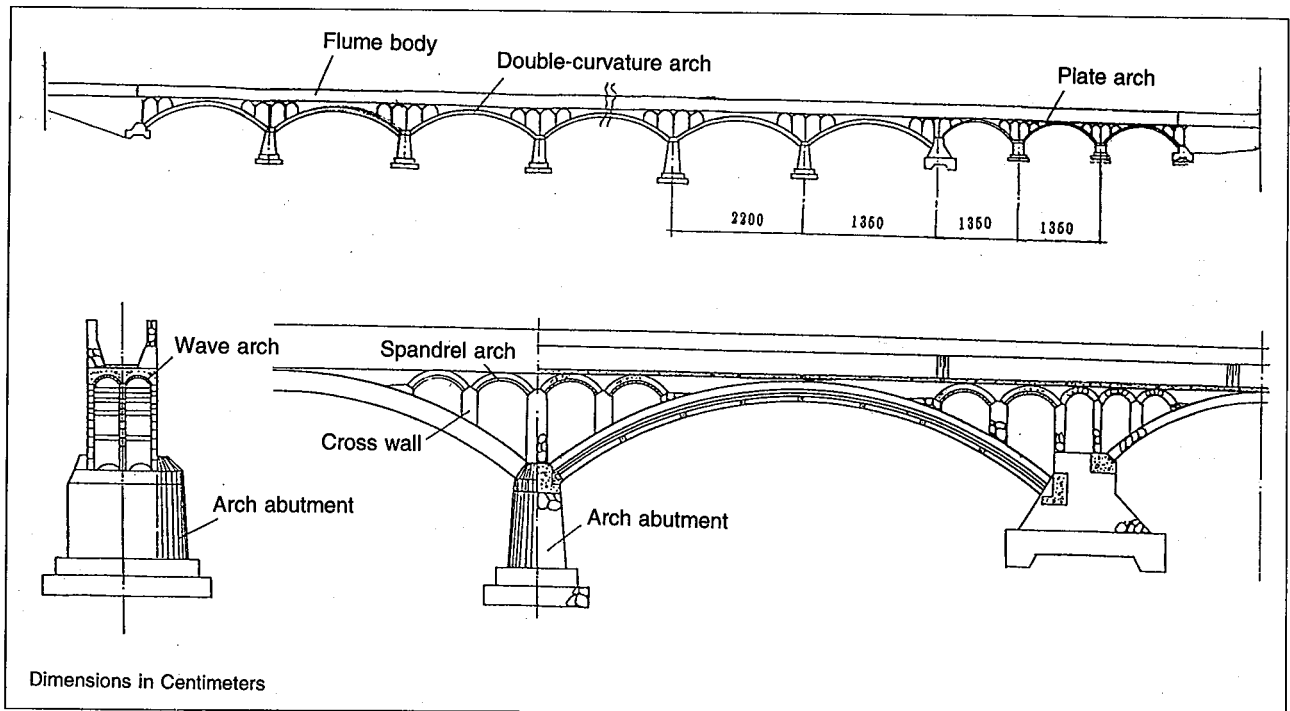
Figure 6.17.3. Details of the Wufan Aqueduct, Hubei Province, China.
