IRRIGATION EFFICIENCY AS A PERFORMANCE PARAMETER IN THE COMMAND AREA OF THE MIDDLE AND LOWER TUNUYÁN RIVER MENDOZA, ARGENTINA

Chambouleyron, Jorge*; Salatino, S.*; Morábito, J.*; Mirábile, C.*

(*) National Institute for Water and the Environment - Andean Regional Center

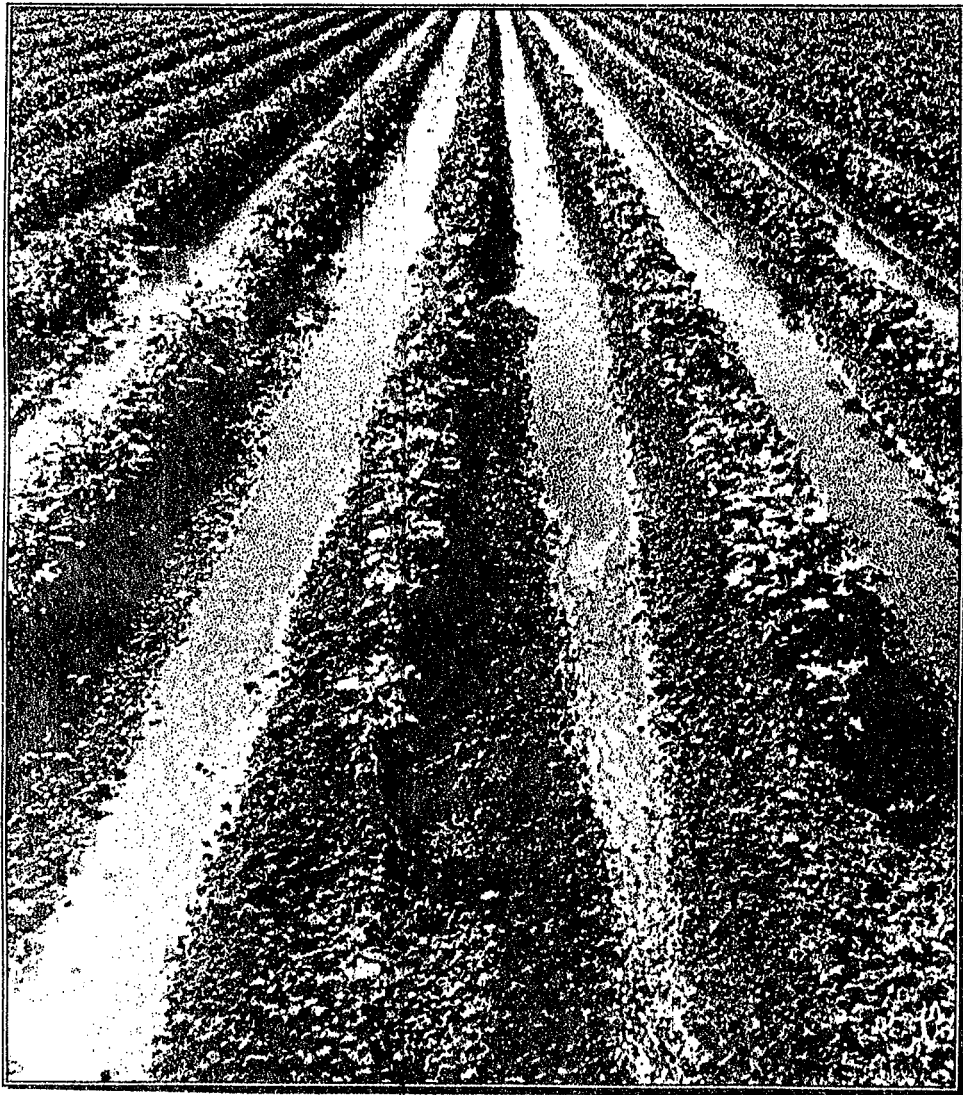
Figure 4. Furrow-irrigated vegetables in the study area.

Vegetables represent a small percentage of the farmed area (Fig. 4). Tomatoes for the canning industry are the prevailing crop, which --due to the mostly loose soils in the area-- produce good yields. Irrigation efficiency figures, however, are low. In general, farmers ignore the soil depth to be wetted each time and apply water depths that are more suitable to the needs of deep-rooted permanent crops, such as vineyards and fruit trees. As a result, they induce considerable percolation, rising phreatic levels, and inefficiencies.

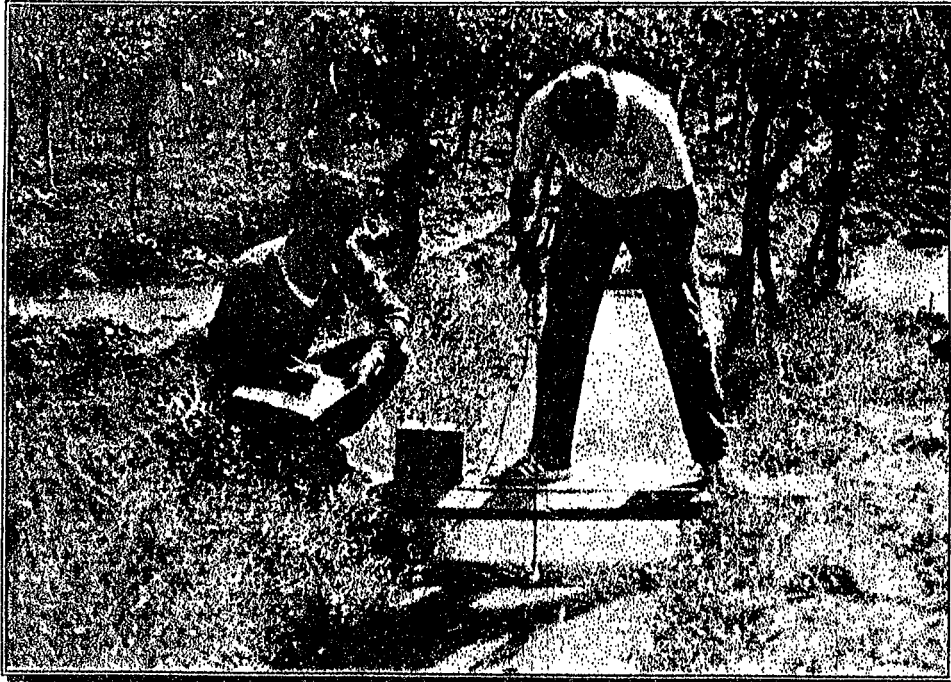
Figure 5. Measuring flows on a farm.

This methodology focuses on the integrated analysis of water use on the farm from its intake. This approach also affords the possibility of measuring conveyance efficiencies and losses along the irrigation network, from the farm's intake to the diversion itself (Fig. 5).
