**PILOT PROJECT FOR FARMER-MANAGED IRRIGATED AGRICULTURE UNDER  
THE LEFT BANK OUT FALL DRAIN STAGE I PROJECT, PAKISTAN**

**MAINTENANCE PLANS FOR IRRIGATION FACILITIES  
OF PILOT DISTRIBUTARIES IN SINDH PROVINCE, PAKISTAN**

*Volume Three*

*Bareji Distributary, Mirpurkhas District*

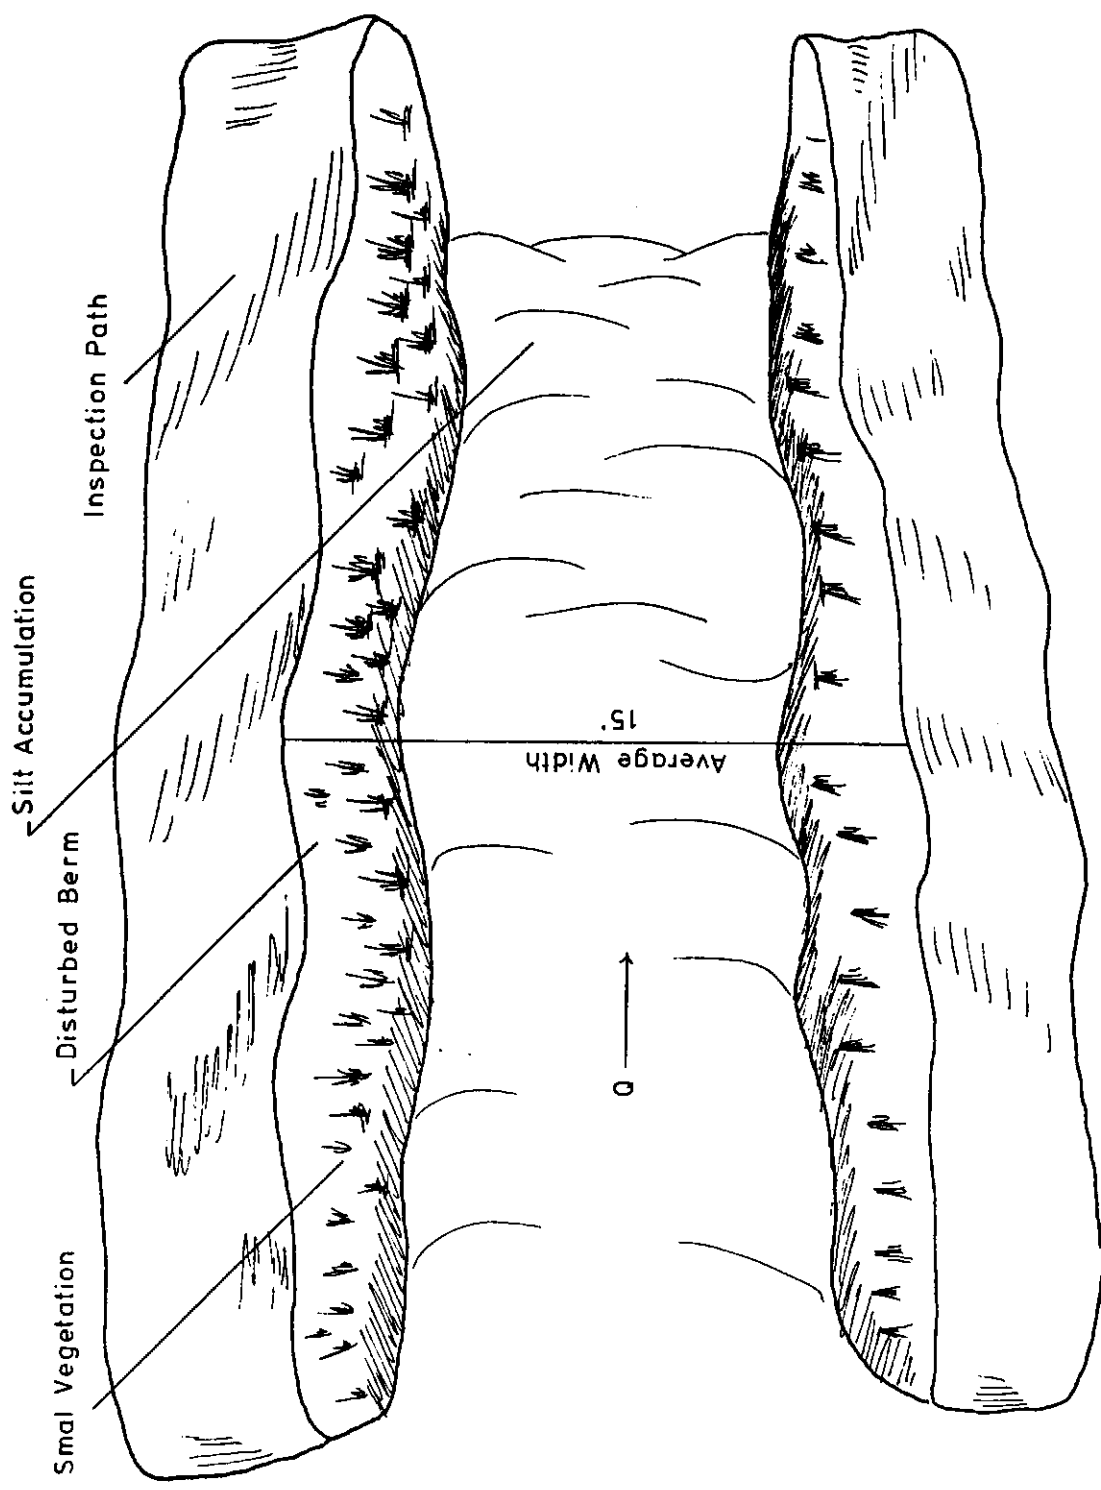
Figure B 4. Sketch of Bareji Distributary from RDs 11.5 to 12.1.

The width has decreased while the depth has increased. This has resulted in increased flow depth. The banks are stable. The berms are not well maintained. Six watercourses offtake from this reach of the distributary. Besides these six legal outlets, one illegal watercourse is being fed from the distributary without an outlet structure. There are two overhead bridges for crossing the channel in this section (see Figure B5).

- Causes** The main reason for deep desilting of the distributary was to get more water at the tail portion because they use lift machines at some watercourses. The tail of the distributary has no outlet structure. The lack of the berm width and adequate freeboard is due to improper maintenance. The banks and the berms are disturbed due to the crossing of animals and the washing of clothes.
- Remedy** Appropriate maintenance practices may be followed in the future to overcome many of the problems being faced presently.
